# Dental Implants Displaced into the Mandibular Corpus: Clinical Note

Antonio Scarano<sup>1\*</sup>, Felice Lorusso<sup>2</sup>, Pablo Santos de Oliveira<sup>3</sup>, Giovanna Murmura<sup>4</sup>,  
Francesco Carinci<sup>5</sup>

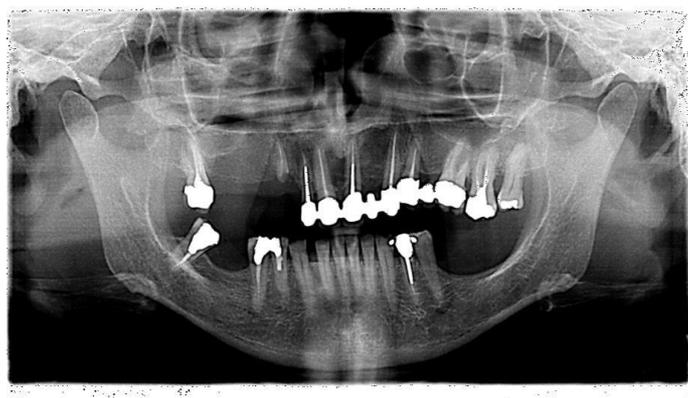
**Figure 1:** Preoperative panoramic radiograph that shows the edentulous ridges of the jaws. The fourth quadrant needs the placement of two dental implants in position 45 and 46, which one in a post extractive socket in the premolar area.

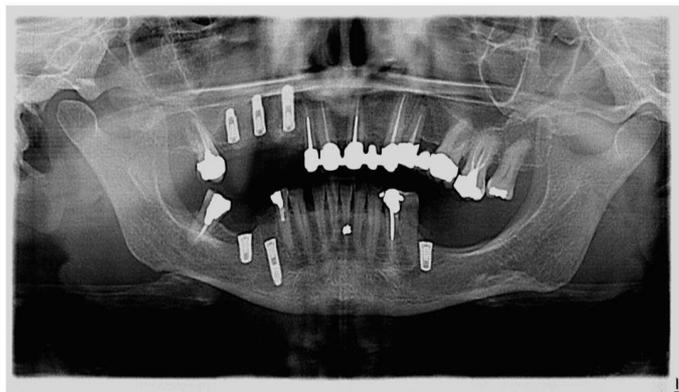
**Figure 2:** Immediate post-operative radiograph. The panoramic scanning shows an implant location near the mental nerve.

After clinical examination, a panoramic radiograph was taken. The radiograph showed the implant located near the mental nerve (Figure. 2). Before the implant was removed, a CBCT radiograph was taken of the exact location of the implant. The radiograph showed the implant in contact with the mandibular inferior border surrounded by a trabecular bone and laterally to the mental nerve (Figure. 3). The implant was removed by screwdrivers, the implant site was filled with a porcine bone xenograft (Tecnoss, Coazze, Turin, Italy) and the new implant was replaced immediately. Intraoral radiographs (baseline) were made with a paralleling technique to calculate the correct position for the implant. The patient was seen after 1 week for suture removal and after one month to evaluate together the surgical intervention.

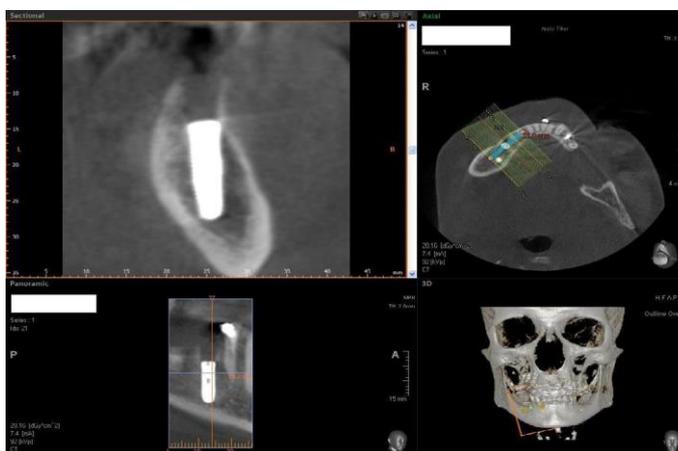
**Figure 3:** CBCT radiograph was taken to clarify the exact position of the fixture in the ridge. The scan shows the implant in contact with the mandibular inferior border surrounded by a trabecular bone and laterally on the mental nerve.

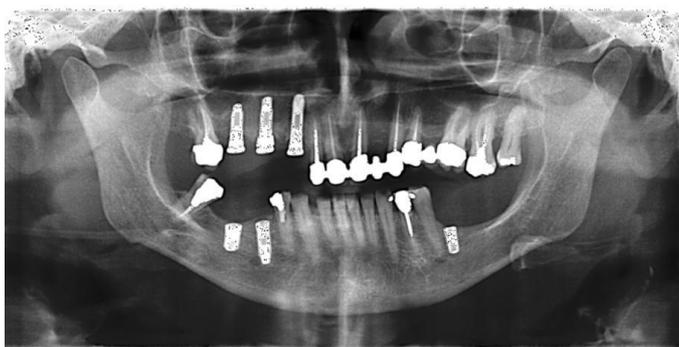
**Figure 4:** Panoramic radiograph taken at 4 months from the surgery. After the submerged healing, the treated site showed a good osseointegration.

After 4 months of submerged healing (Figure. 4), the implant was exposed. The implant was manually tested for stability by loosening the cover screws. Within one-month, provisional screw-retained reinforced acrylic restoration, rigidly joining the implant, was delivered. Four months after delivery of the provisional prosthesis, definitive screw-retained metal-ceramic restoration rigidly joining the implant was delivered. At one week, the prostheses were checked, and the patient was given additional oral hygiene instructions.

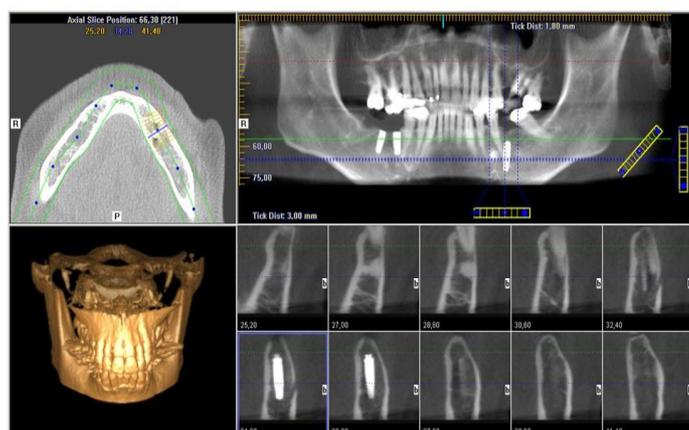
Figure 5: CBCT radiograph showing the implant in contact with the mandibular inferior border surrounded by a large medullary space and laterally on the mental nerve.

After discussing the options with the patient, she agreed to the placement of one implant (Implacil, De Bortoli, Sao Pau-lo, Brasil). No problems were reported during the implant bed preparation and placement but, also in this case, during the positioning of the cover screws the implant disappeared (Figure. 5). Taking the implant with a screwdriver was difficult because it was moving in the mandibular body. After trying to remove the implant with the screwdriver an osteotomy was performed with a Piezosurgery device (Mectron Piezosurgery Device™; Mectron S.p.a., Carasco Genoa, Italy), and the implant was removed with pliers. A bone graft (TecnoSS, Coazze, Turin, Italy) and collagen membrane (TecnoSS, Coazze, Turin, Italy) were used for filling the bone defect and a new implant was placed immediately. After 4 months of submerged healing the implant was exposed. The implants were manually tested for stability by loosening the cover screws. Within one-month, provisional screw-retained reinforced acrylic restorations, rigidly joining the implant were delivered. One month after delivery of the provisional prosthesis, definitive screw-retained metal-ceramic restoration rigidly joining the implant was delivered.

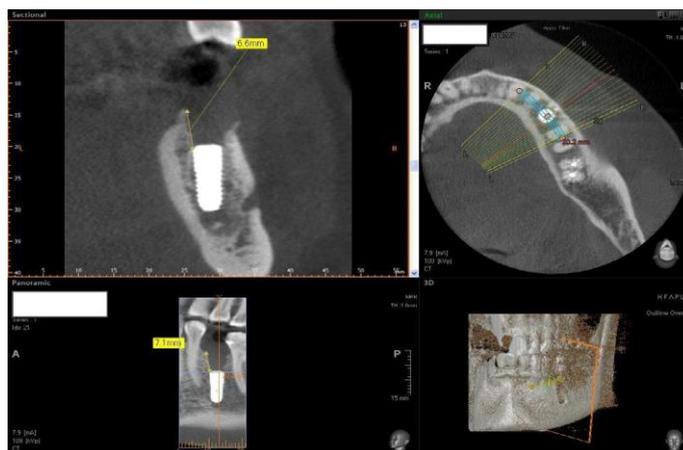
Figure 6: Multiplanar Reconstruction of CBCT scans. The implant appears displaced into the mandibular corpus; a large medullary space was present.
